## Gelitan Extraction – Acid Soak

Gelatin Processing Facility  
September 2009

ECC Corrosion Inc.  
Wisconsin Rapids, WI

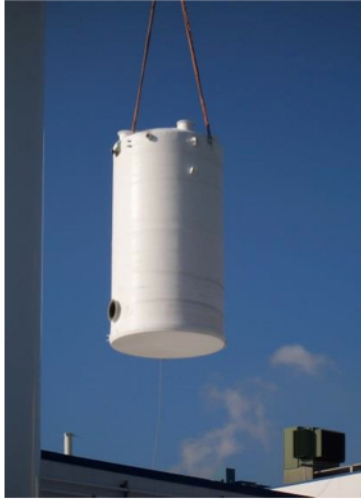
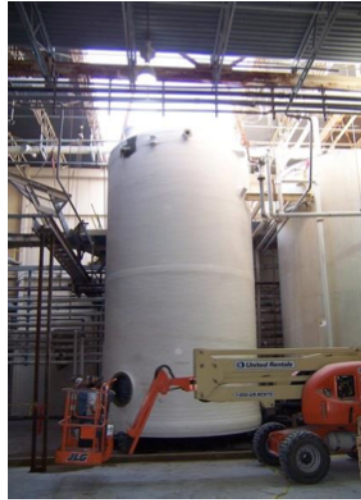
Cerarmix Liner AR-1 / C-1 Blend, 150 Mils  
Resin Swancor 901 – Food Grade Vinyl Ester  
Structure: Filament wound, w/Advantex ECR  
glass, and Swancor 901, MEKP cure system

- (4) 14'D x 26' Str. Wall
- Internal slope 0-30 Deg
- False bottom.

Fiberglass Structure was design to replace Carbon Steel Flake Glass lined and Rubber liner tanks. Flake glass linings had a service life of 8-10 years, with substantial repairs after the fifth year in service. (Erosion/corrosion issues)

Poor service life of linings and atmospheric corrosion lead engineering to a fiberglass reinforce plastic (FRP) tanks. The tanks internal slope and false bottom made the design a challenge – yet solved the problem of costly relines and down time.
