Wall Restoration - Food Processing Plt.

Tyson Foods – Waterloo, IA Fall 2013

L & P Painting Inc.

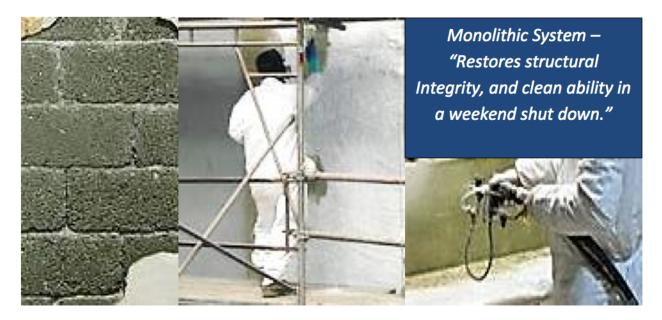
Vinyl Ester Resin System - Dion 382 Cerarmix VE-MR @ 200-250 mils 1.5 oz. Mat reinforced Topcoat/Gelcoated with 12-16 mils (Semi-gloss finish)

- Standard 8" Cement Block
- Holes and erosion in block from Cleaning chemicals and fatty acids.
- Large aggregate visible throughout the surface

The wall system has performed remarkably well. It handles all cleaning and sanitation processes better than traditional coatings. Plant sanitation practices using CIP chemicals, high pressure hot water, as well as steam have had no effect on the Cerarmix materials.
